A NEW APPROACH FOR OPEN AIR INSULATOR TEST STATIONS: EXPERIENCE FROM TALOS AND THE POLYDIAGNO PROJECT

Key words: insulator, high voltage, test station, leakage current, weather, monitoring, DAQ, DAS, Labview

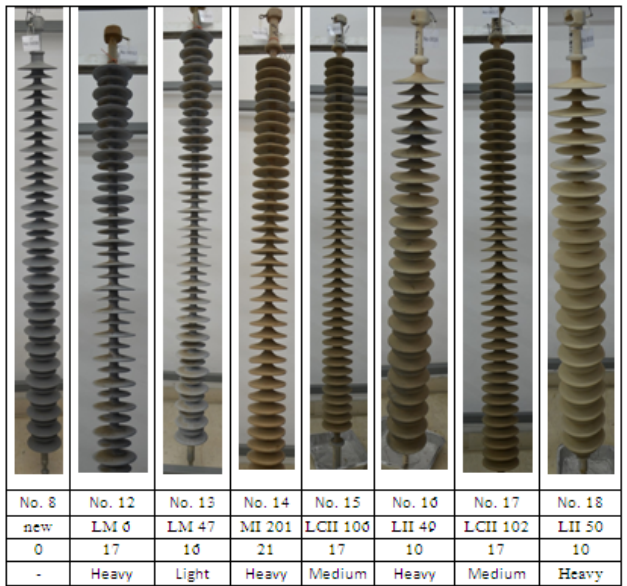
Fig. 1: The insulators removed from the network for POLYDIAGNO (No. 12-18) along with the respective tower, the years in service and the pollution severity of the site. A new insulator was also used for lab tests as control (No. 8)

research scheme includes HEDNO (TALOS), the Technological Educational Institute of Crete, the Foundation for Research and Technology-Hellas and ENTEC Green Economy Consultant. The project is focused on investigating the performance and aging of composite insulators [15-18]. The insulators considered for the project were chosen so as to portray a variety of induced stresses [12, 19-21]. Seven 150kV towers were selected and three insulators were removed from each tower. A photo of the insulators used for lab tests (one of each three) is shown in Figure 1, along with the basic data (tower, years in service, site pollution severity). The actual location of each tower along with the pollution severity of the site and the years in service is shown in Figure 2.

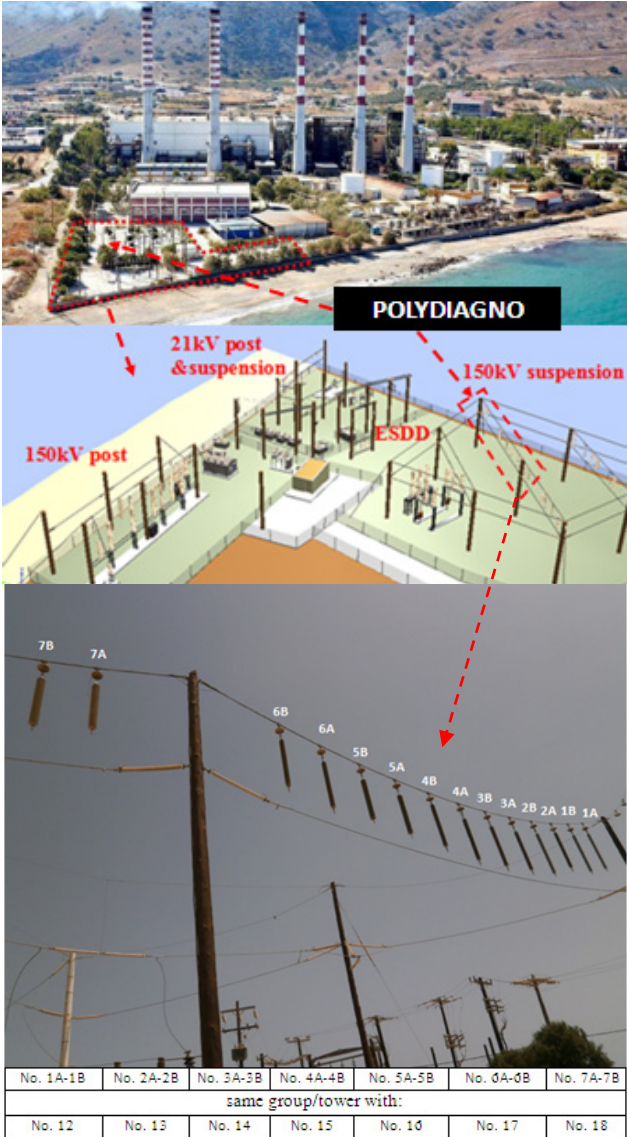
Fig. 3: The location of TALOS along with a 3D model and a photo from the POLYDIAGNO insulators installed in the 150kV suspension bay.

years in service for the removed insulators and the site's pollution severity (SPS)
The location of TALOS, along with a 3D model and a photo from the POLYDIAGNO insulators installed in TALOS are shown in Figure 3.

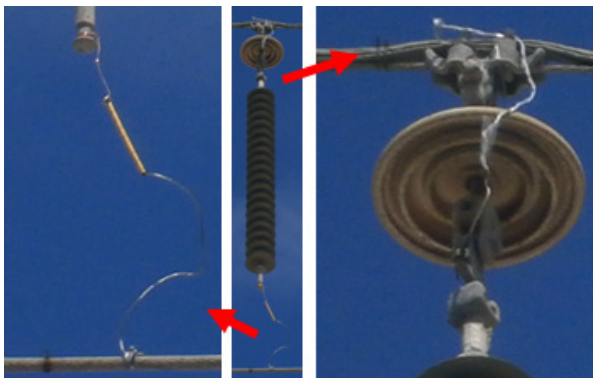
Fig. 5. The initial set-up at TALOS. Zoomed in for the stand-off insulator and the expulsion fuselink.

The general scheme for leakage current monitoring as described in [3] and followed by various testing stations worldwide (e.g. most recently in [22]), includes the use of a stand-off insulator installed at ground side in order to guide the current through the LC sensor which is connected to a Data Acquisition System (DAS) and an expulsion fuselink connected to the HV side for protection and isolation purposes. This general approach is depicted in Figure 4. The initial approach in TALOS followed this exact scheme as shown in Figure 5.

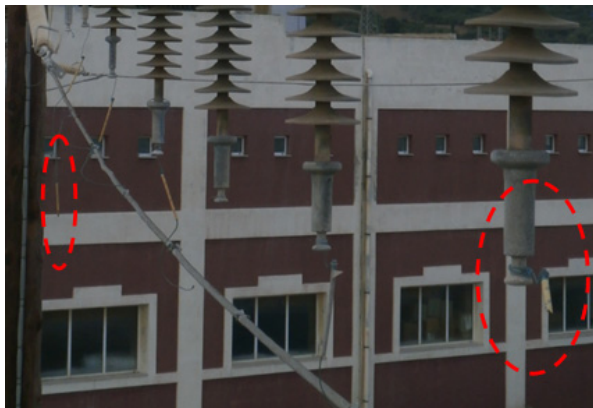
Fig. 6. A close-up photo from 150kV suspension insulators installed in TALOS following the initial scheme. The connecting wire of the far left fuselink has been cut off and the far right fuselinks has shattered.

However, it soon became obvious that such a scheme had a weak link: the mechanical strength (endurance) of the expulsion fuselinks part. Under the frequent strong winds that prevail in the island of Crete, the fuselinks and/or their connector wires tended to shatter and/or cut off as shown in Figure 6.

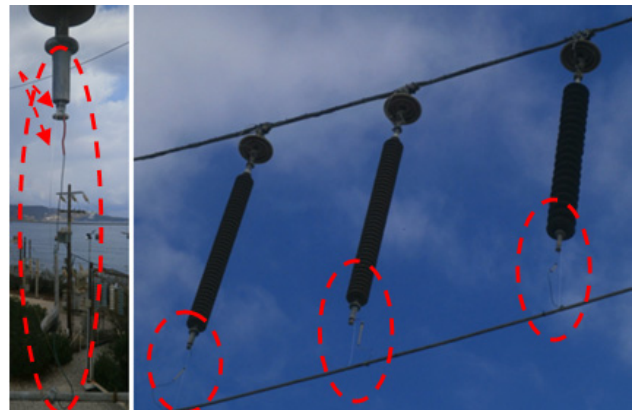
Fig. 7. Close ups from 150kV suspension insulators installed in TALOS with a non-conductive high strength net used to absorb the mechanical stress.

This was proved to be a significant issue for the operation of the test station, as such faults could not be repaired online. As a first remedy, a non-conductive high strength net was installed, as shown in Figure 7, in order to not allow insulators to swing freely in all directions and to absorb the mechanical stress. The length of the net was obviously chosen to be shorter than the length of the fuselink/connector part. However, this did not seem to be able to solve the problem: the net was often found intact, however the fuselinks and their connecting wires continued to shatter, as shown in Figure 8.

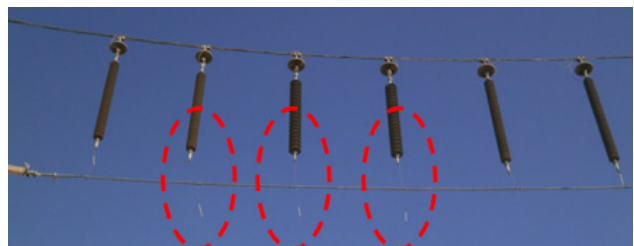
Fig. 8. A photo from Insulators installed in TALOS using a nonconductive net to absorb mechanical stress. The net was often found intact whereas the fuselinks and/or their connective wires were shattered.

This was attributed to the fuselink swinging, i.e. even though the net succeeded in stopping the insulator from swinging, the movement of the fuselink was enough to gradually overstress and shatter the connecting wires and/or the fuselinks. The next logical step was to mount the fuselink on the net. However, this also failed to solve the problem as shown in Figure 9.

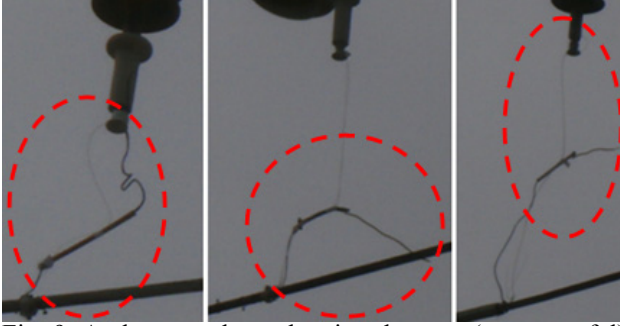
Fig. 9. A close up photo showing the next (unsuccessful) step: fuselinks mounted on the non-conductive net.

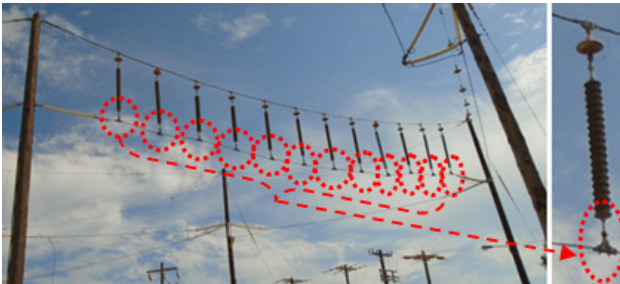
Fig. 10. The final set-up scheme followed in TALOS. The expulsive fuselinks have been fully removed.

The final approach was to fully remove the fuselinks. The obvious disadvantage of such an approach is that a flashed over insulator may require shutting off the whole bay or the test station. However, the fault free performance of composite insulators for a long time period in the Cretan network [10, 11] hinted that this should be considered a minor problem in this particular test station (and as long as composite or coated insulators were the ones tested). Photos of the final set up scheme are shown in Figure 10.

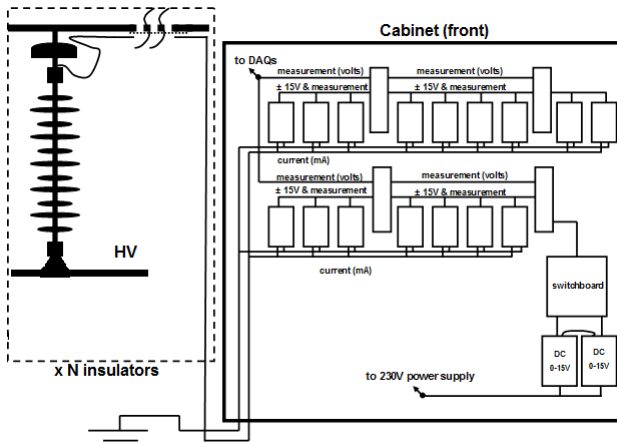
Fig. 11. The leakage current monitoring scheme now followed in TALOS High Voltage Test Station (150kV bay)

An added variation from the basic scheme proposed in [3] is that sensors and DAQs were housed in a cabinet so as to be easily accessible and protected from the weather (Figure 11 and Figure 12).

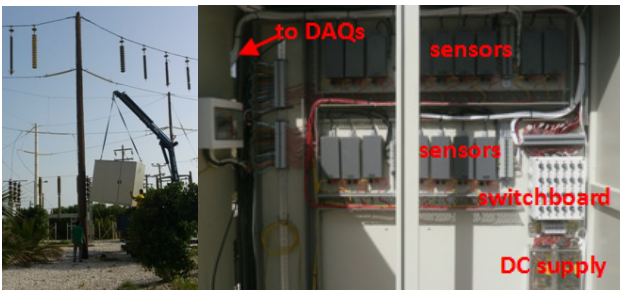
Fig. 12. Photos from the cabinet used top house sensors and DAQs

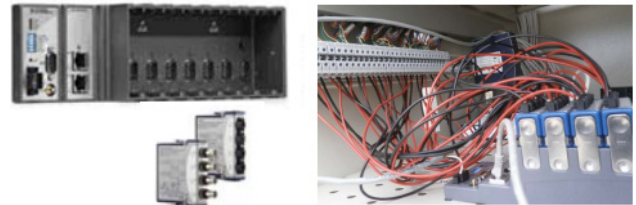
Fig. 13. The cRIO-9074 chassis, the NI 9229 modules and the system installed in the cabinet

The choice was a National Instruments rugged and reconfigurable chassis (cRIO-9074 [34], Figure 13) equipped with 8 slots, a microprocessor and user-programmable FPGA. Several multiple hot-swappable I/O modules are available for this chassis. However, as leakage current Hall sensors from the previous DAS [3, 22-32] were already available and operational, the modules currently used are of NI 9229 type [35] that have 4 differential channels with an input range of $\pm 60V$ suitable for the $\pm 15V$ output of the sensors (Figure 13).

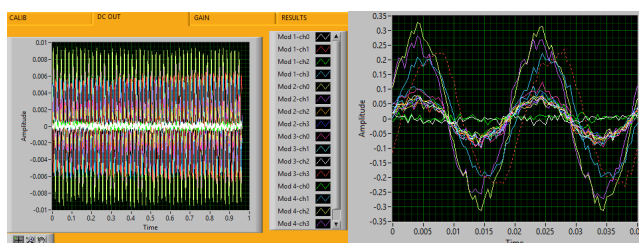
Fig. 15. The filtered signal (DC OUT tab) and a zoom-in on the waveforms after the gain application (GAIN tab)

The Labview software along with the Labview Application Builder and the Labview Real Time Module were also purchased to allow the stand alone operation of the DAQ. A custom made software was developed capable of removing the DC offset and then calculating certain values (positive and negative peak, RMS, harmonic ratios, THD, positive and negative charge). A user-defined gain was available for each channel in order to incorporate each sensor's transfer function (and losses). The time-windows used to calculate and save the values (i.e. the buffer size), are also user-defined. A txt file is created daily so that the recordings can be easily viewed and manipulated by other software. Instances of the software are shown in Figures 14-15.
