SFRA ability in detection of Deformation in Transformers Windings: A field experience of 400kV 167MVA single phase unit

Gujarat Energy Transmission Corporation Limited (GETCO)
Vadodara, India

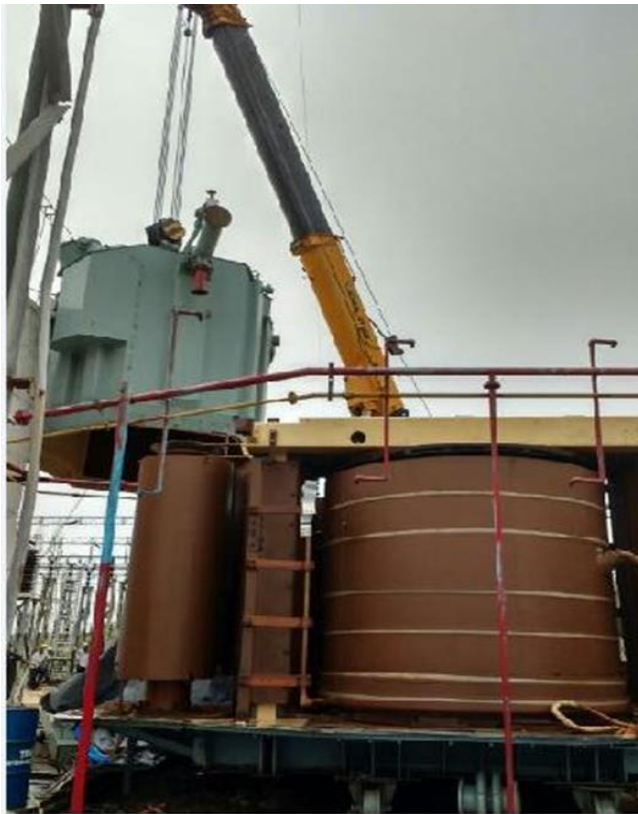
Fig. 3. Inspection of active part of transformer

After the removal of oil, main tank lifted at site, thorough inspection of winding was carried out and nothing found abnormal in the transformer. After completion of internal inspection oil filtration and drying out process for power transformer was carried out. All the required tests performed again to check whether the proper fitting and filtration was done or not. All the test results were found satisfactory. The distortion in tertiary winding which was noticed in earlier test i.e. SFRA, could not be observed after opening of transformer, as winding was covered with hard board insulation and nothing can be visualized in inspection as shown in figure 3.

As in above mentioned tests, results did not give any clear idea about the fault. As DGA indicated increment in key gases, capacitance and tan delta indicated movement in tertiary winding and SFRA indicated buckling in tertiary winding, it was decided to open the transformer using air dryer plant for inspection. As transformer was bell type, huge crane required for lifting of tank.

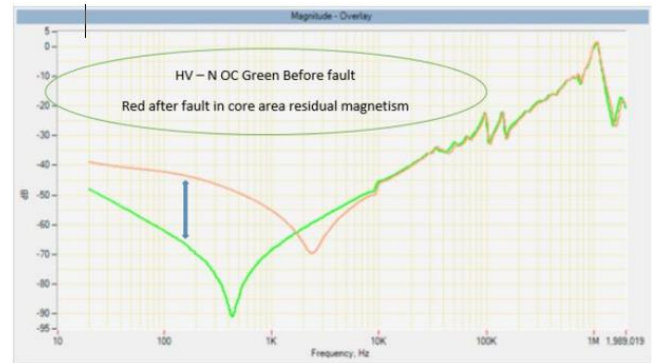
Fig. 4. SFRA of HV winding before OH and after LA fail

SFRA for each winding was done and compared with its base which was available before overhauling (OH). For SFRA of H.V. winding, source was injected from H.V. winding and its response was measured at neutral, comparison was done with its base is shown in figure 4.

In SFRA test results, difference in core area (low frequency region) was noticed, while there was not any deviation in winding area (high frequency region). The difference in core area was due to residual magnetism.

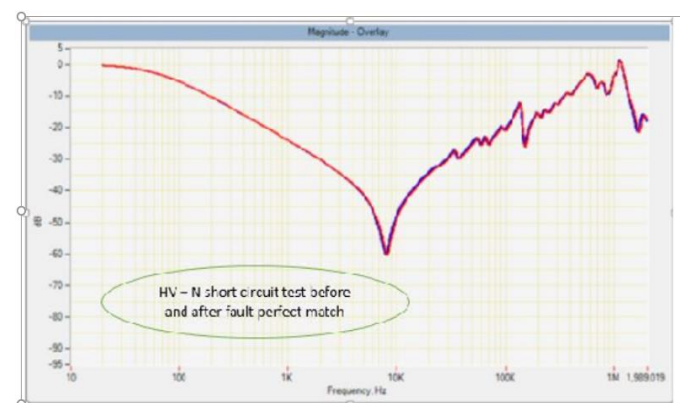
Fig. 5. SFRA of H.V. SC before OH and after LA fail.

To verify the effect of residual magnetism, SFRA was conducted again with shorting of tertiary winding and the response is shown in figure 5. The results clearly show that there is no any deviation in SFRA results which indicates that H.V. and L.V. both windings are intact.

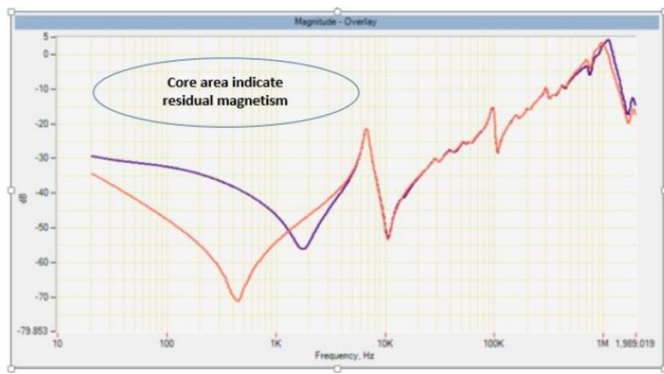
Fig. 6. SFRA of L.V. winding

SFRA test of L.V. winding was also done and compared with its available fingerprint, difference in core area (low frequency region) was observed which was due to residual magnetism, however, no deviation observed in winding area (high frequency region) as shown in figure 6. Hence L.V. winding was also found intact.

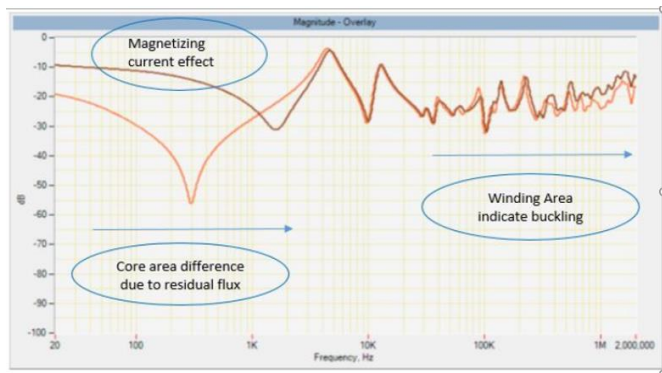
Fig. 7. SFRA of tertiary winding

SFRA test was performed on tertiary winding and its results was compared with its fingerprint and as usual, difference noticed in core area but as mentioned earlier the reason was residual magnetism, in addition deviation in winding area was also observed as shown in figure 7.

As the deviation in winding area was noticed, and it was concluded that there could be buckling in tertiary winding and same was confirmed with tan delta test as there was change in capacitance of tertiary winding.

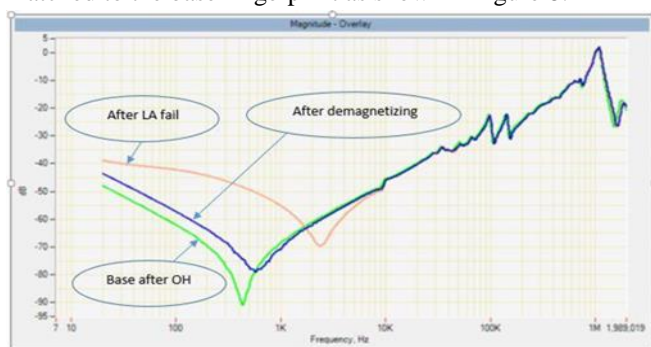
Fig. 8. SFRA of H.V. winding after demagnetization

To re-verify the effect of residual magnetism it was decided to demagnetize the transformer by using demagnetizing technique and once again individual SFRA test on all windings were carried out. After demagnetizing, the trace of H.V. and neutral in low frequency area almost matched to the base fingerprint as shown in figure 8.

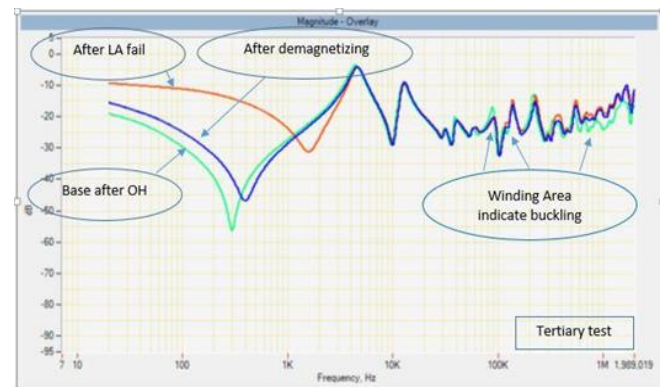
Fig. 10. SFRA of tertiary winding after demagnetization

In tertiary winding also the effect of residual magnetism was almost nullified, however, the deviation was noticed once again in winding area as shown in figure 10.

So, now it could be said that there should be some deformation in tertiary winding.

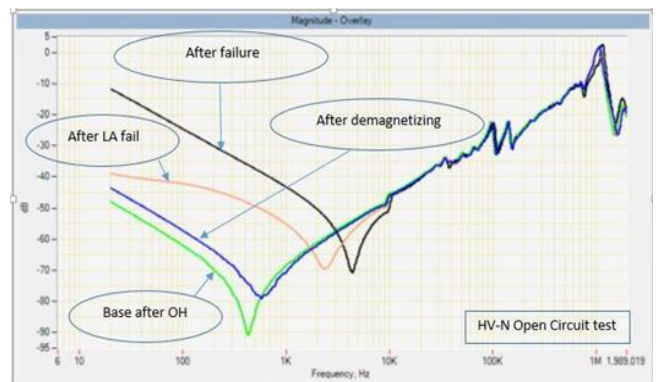
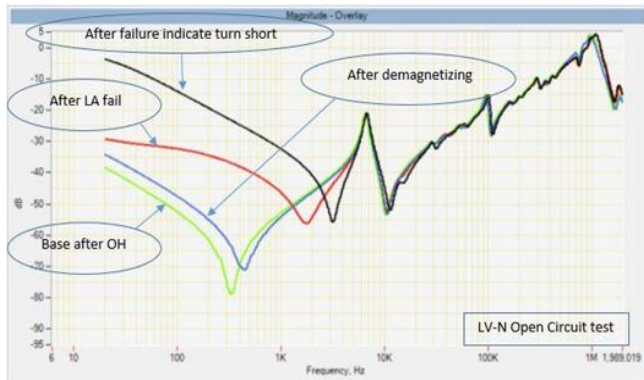
charge the transformer with all necessary safety precautions. At the instant of transformer charging, transformer was tripped. So, all tests i.e. Tan deltas, low voltage test, DGA, DC winding resistance and SFRA were performed again. All individual SFRA results of H.V. and L.V. windings were compared as shown in figure 11 and 12 respectively. As shown in figure 11 and 12, low frequency area indicated turn to turn short. However, there was no deviation in winding area which means that turn to turn short should be in tertiary winding.

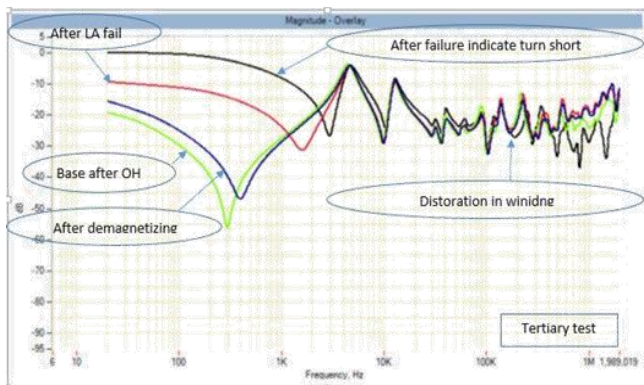
Fig. 13. SFRA of tertiary winding after tripping

All the SFRA results of tertiary winding were compared as shown in figure 13 and deviation in low frequency and high frequency area was clearly observed, which indicated turn to turn short in tertiary winding.

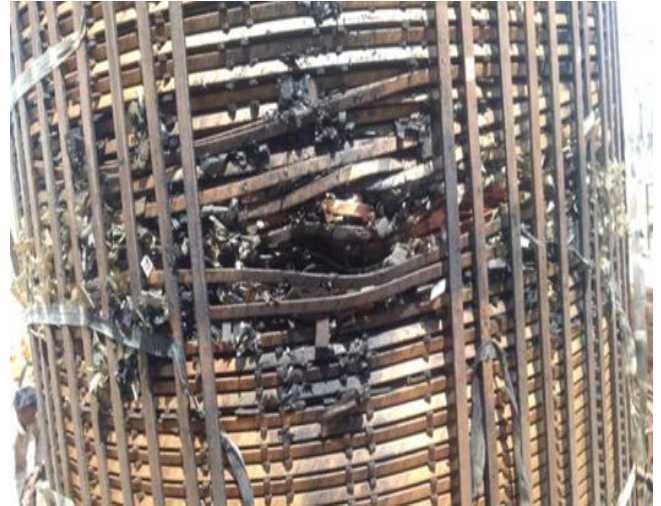
Fig. 14. Buckled tertiary winding with turn to turn short

Transformer was declared failed and to verify turn to turn short in tertiary winding, transformer was dismantled at site. H.V. and L.V. windings found intact and turn to turn short in tertiary was noticed as shown in figure 14.
