# EFFECT OF RESIDUAL MAGNETISM ON THE MAGNETIC CORE OF A TRANSFORMER

**Abstract:-** Transformer is the most important unit in an electrical distribution network. All transformers are subjected to various tests at the manufacturer's test laboratory before dispatch to the destination of erection. Tests are part of a manufacturer's internal quality assurance program .A manufacture's own criteria have to be fulfilled in addition to requirements specified by customers and applicable standards. Differing requirements are generally combined and published in national and international standards[1]. The primary standards organizations are IEC (International electro technical commission) and ANSI(American Standards). Every transformer has to undergo the pre commissioning tests. In this paper we have concentrated on the magnetic balance test. The transformer which was found to have a perfectly balanced magnetic core during the testing in the factory, and the same transformer which failed to pass the magnetic balance test at site is explored with measured results. The application of a D.C voltage has caused these changes in the core balance of the system and in the magnetizing currents. It is

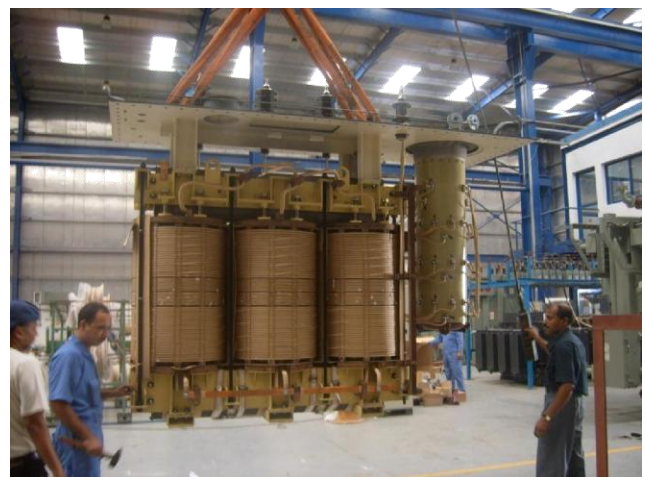
**Figure I. Test Specimen**

Magnetic Balance test is carried out by applying a low single phase voltage at 50 or 60 Hz to each H.V winding in succession and measuring all the other voltages both on high voltage and low voltage side . Under ideal conditions, the results on each limb conform to a particular pattern, depending upon the magnetic lengths to be traversed by the flux the reluctance of the various portions and the division of the flux in the return paths provided by the remaining two limbs.

Experimental investigation was carried on 5000KVA, 33KV/11KV, Dyn11 transformer as specified above in the factory.
